STM32F042x4/x6 device errata

This document applies to the part numbers of STM32F042x4/x6 devices and the device variants as stated in this page.

It gives a summary and a description of the device errata, with respect to the device datasheet and reference manual RM0091.

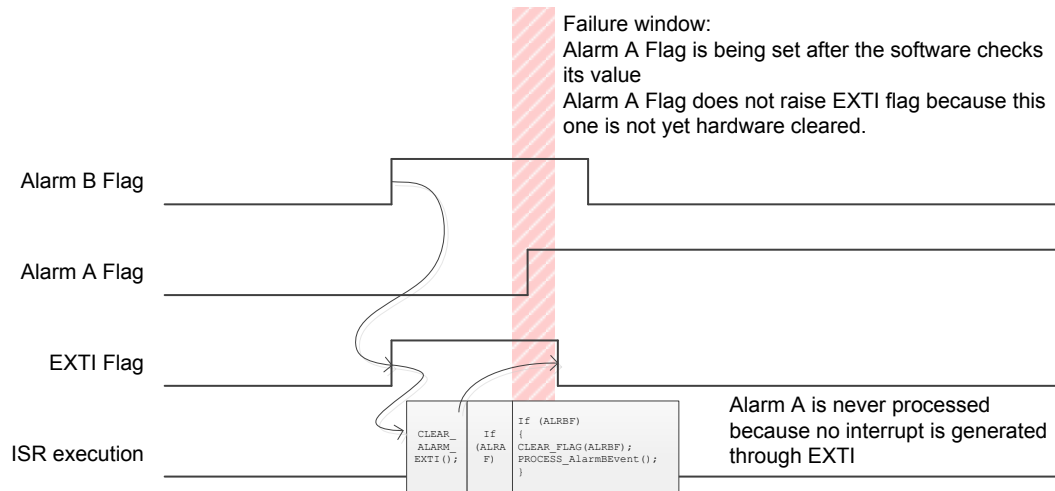
Figure 1. Masked RTC interrupt

The following code example and figure illustrate the failure mechanism: The Alarm A event is lost (fails to generate interrupt) as it occurs in the failure window, that is, after checking the Alarm A event flag but before the effective clear of the EXTI interrupt flag by hardware. The effective clear of the EXTI interrupt flag is delayed with respect to the software instruction to clear it.

```
void RTC_Alarm_IRQHandler(void)
{
    CLEAR_ALARM_EXTI(); /* Clear the EXTI line flag for RTC alarms*/
    If(ALRAF) /* Check if Alarm A triggered ISR */
    {
        CLEAR_FLAG(ALRAF); /* Clear the Alarm A interrupt pending bit */
        PROCESS_AlarmAEvent(); /* Process Alarm A event */
    }
    If(ALRBF) /* Check if Alarm B triggered ISR */
    {
        CLEAR_FLAG(ALRBF); /* Clear the Alarm B interrupt pending bit */
        PROCESS_AlarmBEvent(); /* Process Alarm B event */
    }
}
```

In the interrupt service routine, apply three consecutive event flag checks - source one, source two, and source one again, as in the following code example:

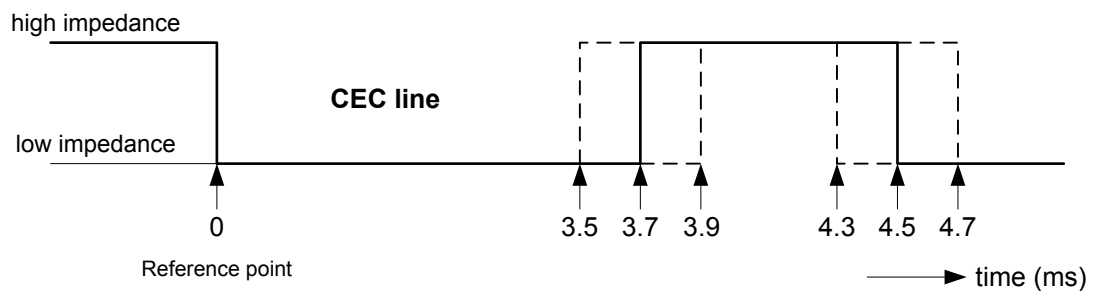
Figure 2. HDMI-CEC start bit format with tolerances

This failure is unlikely to happen as the CEC start bit corruption by another device can only occur if that device does not respect the CEC communication protocol.

The start bit timing standard tolerances are shown in the following figure. The start bit is initiated by the device by driving the CEC line low (reference point). After 3.7 ms, the device releases the CEC line and starts checking its level. The following conditions must be met for the start bit to be valid:

If one of these conditions is not met, the transmission is aborted and never automatically retried. No error flag is set and the TXSOM (Tx start of message) bit is not cleared.

The only way to detect this error is for the application software to start a timeout when setting the TXSOM bit, restart it upon ARBLST or any RX event (as the transmission can be delayed by interleaved reception), and stop it upon TXBR (proof that the start bit was transmitted successfully) or TXEND event, or upon any TX error (which clears TXSOM). If the timeout expires (because none of those events occurred), the application software must restart the HDMI-CEC peripheral and retransmit the message.
