CHANGE NOTIFICATION

PCN#061715

Subject: Notification of Change of Crystals on the LTP5900/LTP5901/LTP5902

Failure Analysis Report

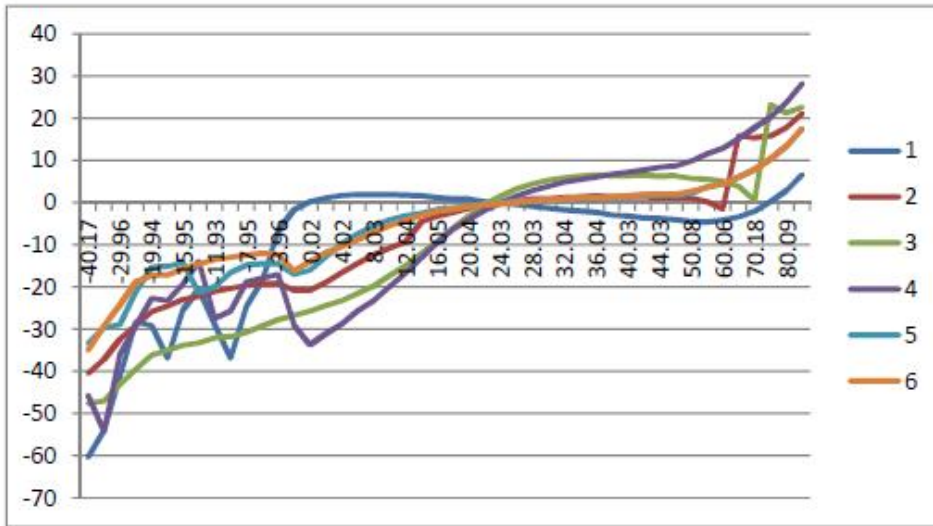
Units were found to be out of spec over temperature

The root cause of this temperature characteristic problem is because of the blank's angle spread is getting bigger and has poor concentration which is related with the raw material's angle and smoothness as show in temperature data above.

We are moving forward with precision blank s for this item (New blank with ECD<100 and Q value = over 2.4 mil.), we asked blank manufacturer to build up with good quality quartz wafer and better as we already decided to use new blank s for this item

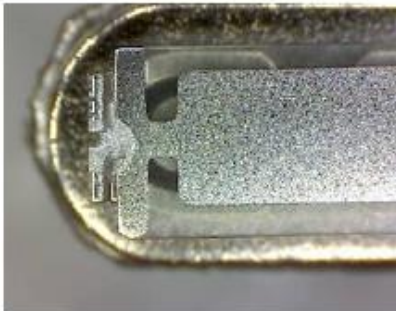
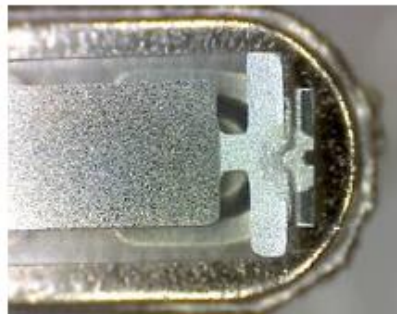
#1 crystal.

3 units were decapped, No damage to the Electrode was observed.
