CHANGE NOTIFICATION

PCN#061715

Subject: Notification of Change of Crystals on the LTP5900/LTP5901/LTP5902

Failure Analysis Report

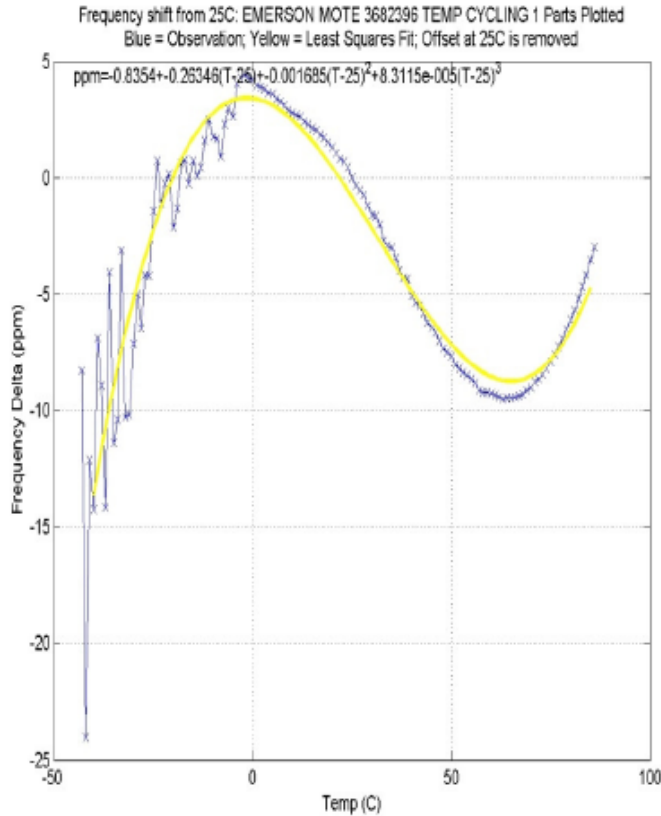
The crystals are a samples of those that failed after thermal shock (-55/125 degC, 500 cycles). Crystals have failed in circuit at cold.

Units were found to be out of spec over temperature

Units were leak tested, parts tested good.

3 units were decapped, No damage to the Electrode was observed.

The temp. stability failure is due to blank angle, We checked blank supplier and asked them to trace and check about the blanks they supplied

The root cause of this temperature characteristic problem is because of the blank's angle spread is getting bigger and has poor concentration which is related with the raw material's angle and smoothness as show in temperature data above.
